Roof Condition Report

Inspection Date: 7/4/1776
Inspection Type: Roof Condition Report

Facility Name
Address
City, State
Building Type: Building Type
Neighborhood: Neighborhood

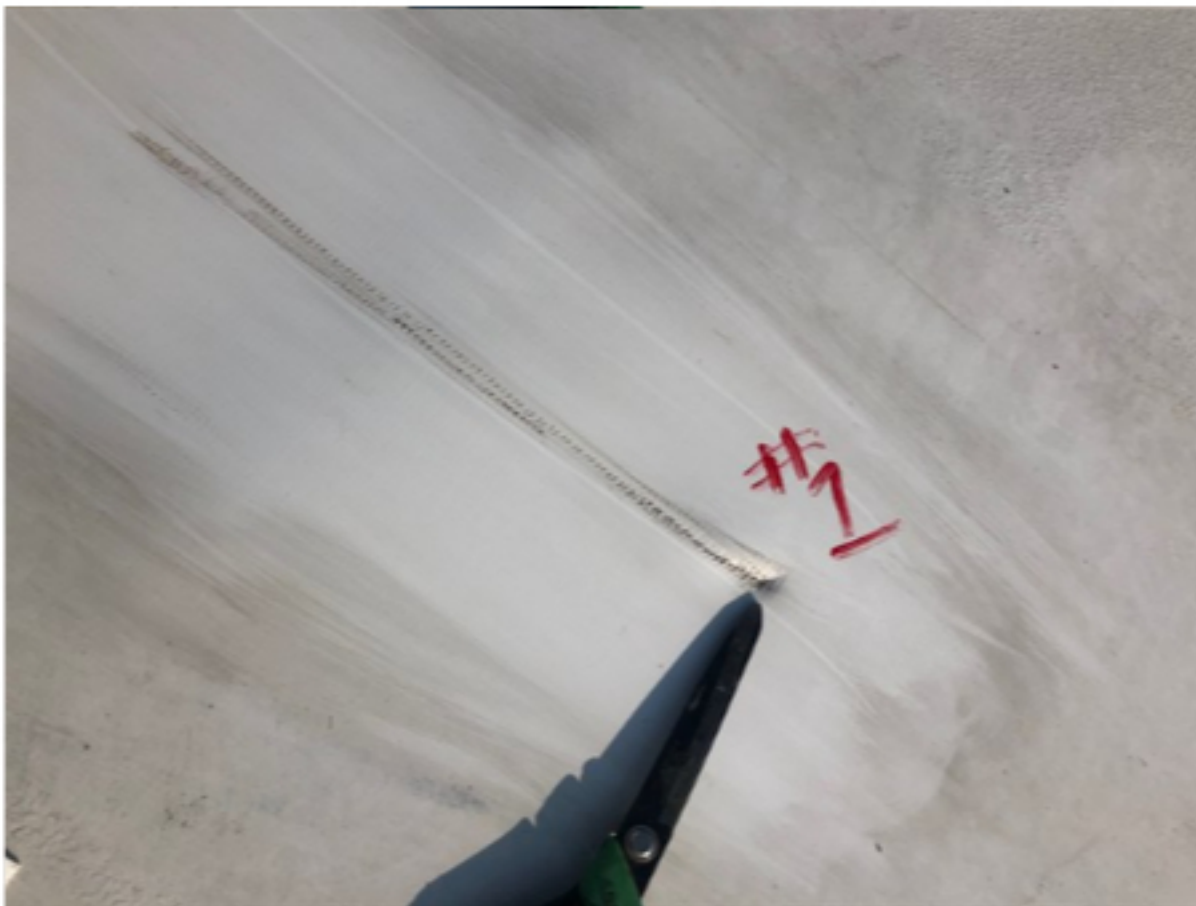
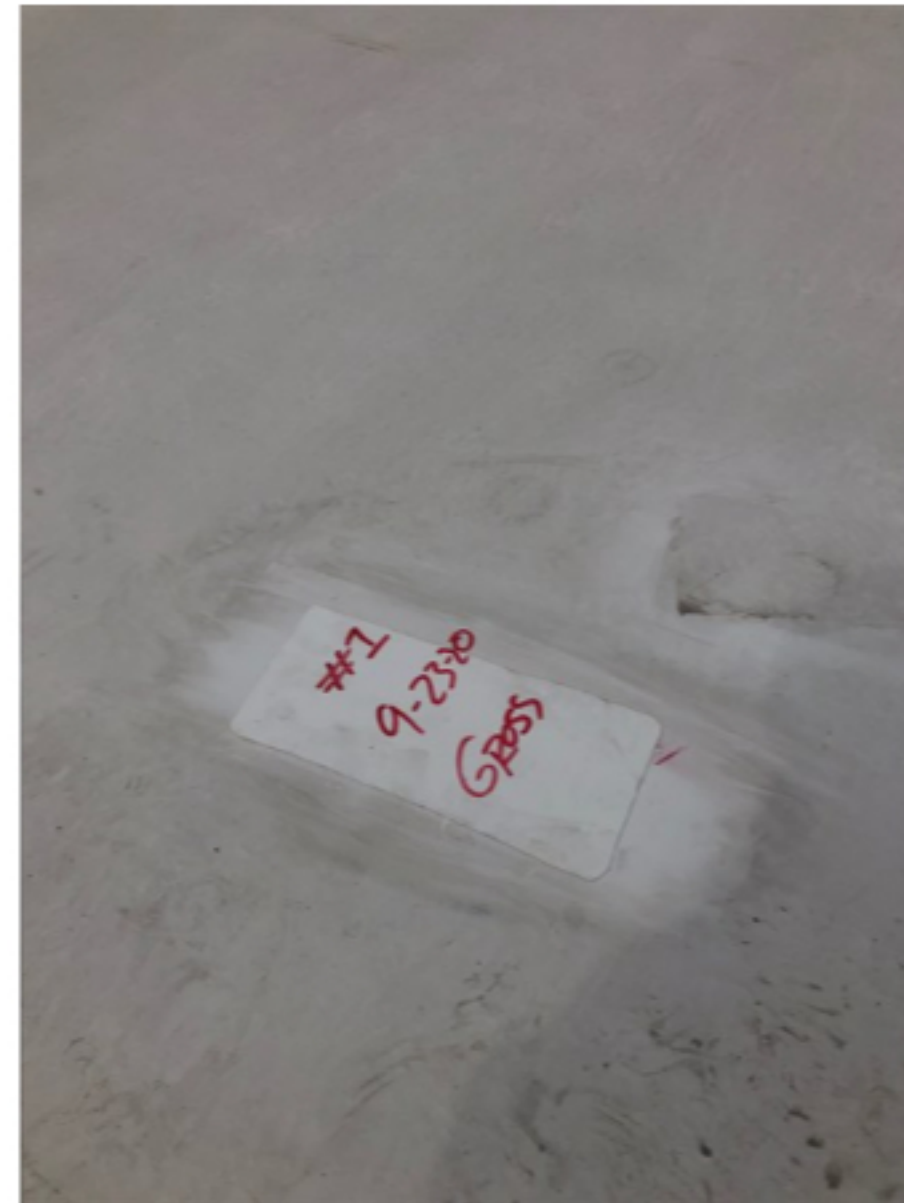
Section 1 Issue #1 Deficiency #1

Deficiency	Description	Deficiency Effect	Severity	Action
Tear or cut	Tear, Cut, or Abrasion of the EPDM membrane could permit water to enter the roofing system.	Lack of action to correct a tear or cut in the membrane will promote saturation of the roofing system. Long term neglect of this condition could contribute to premature failure of the roof area.	Major	Repaired

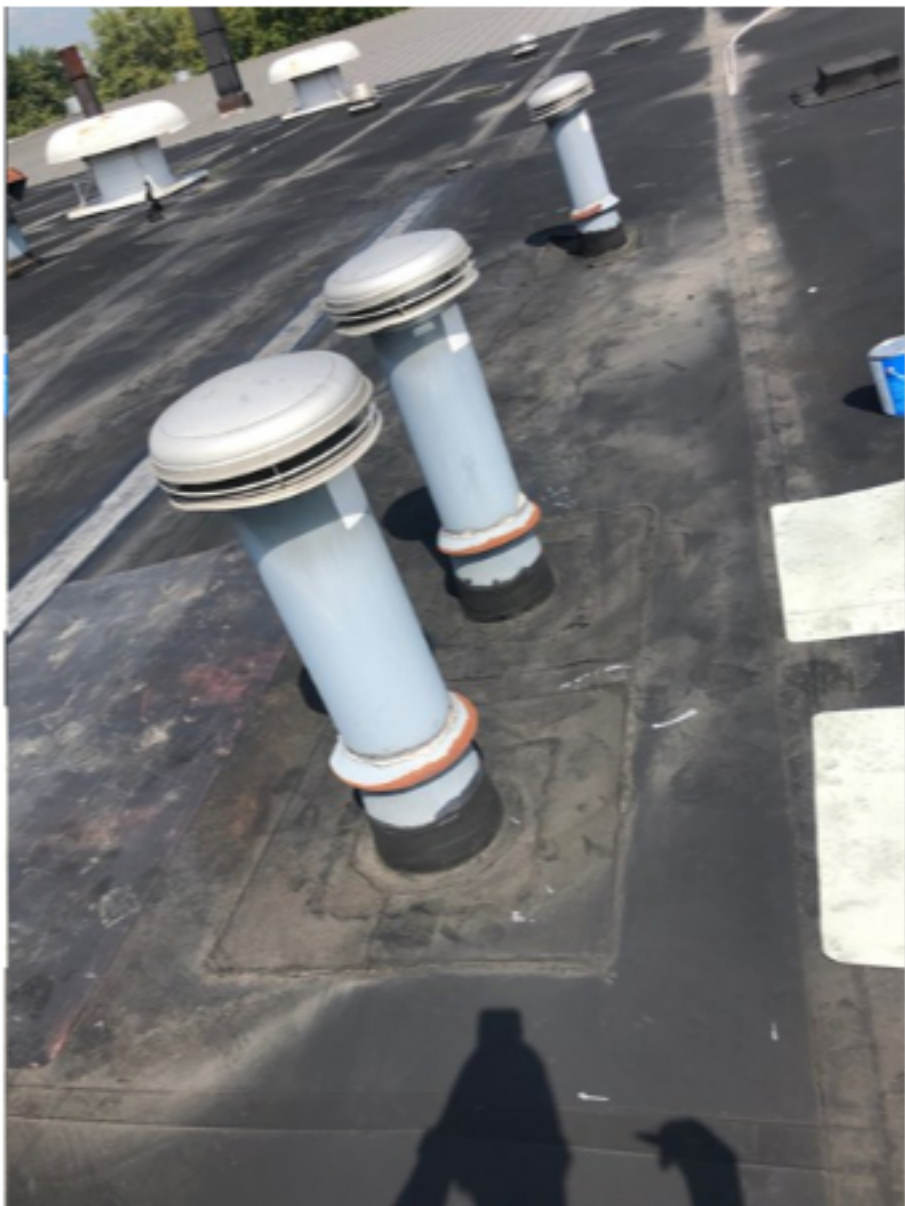
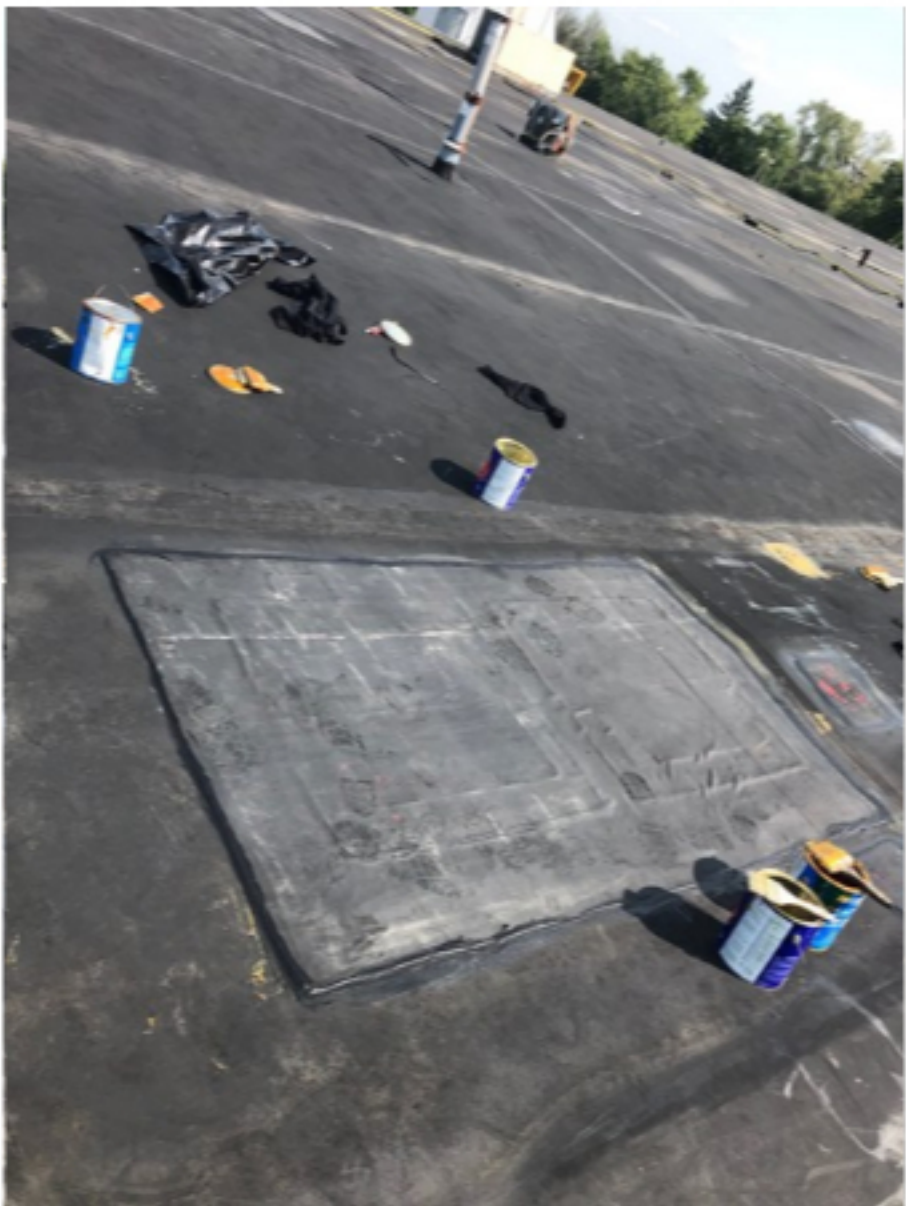
Section 1 Issue #2 Deficiency #1

Deficiency	Description	Deficiency Effect	Severity	Action
Inactive equipment	Roof-top equipment or other penetrations that are no longer in use.	The removal of inactive equipment or other penetrations is recommended to reduce potential areas for water infiltration.	Major	Repaired

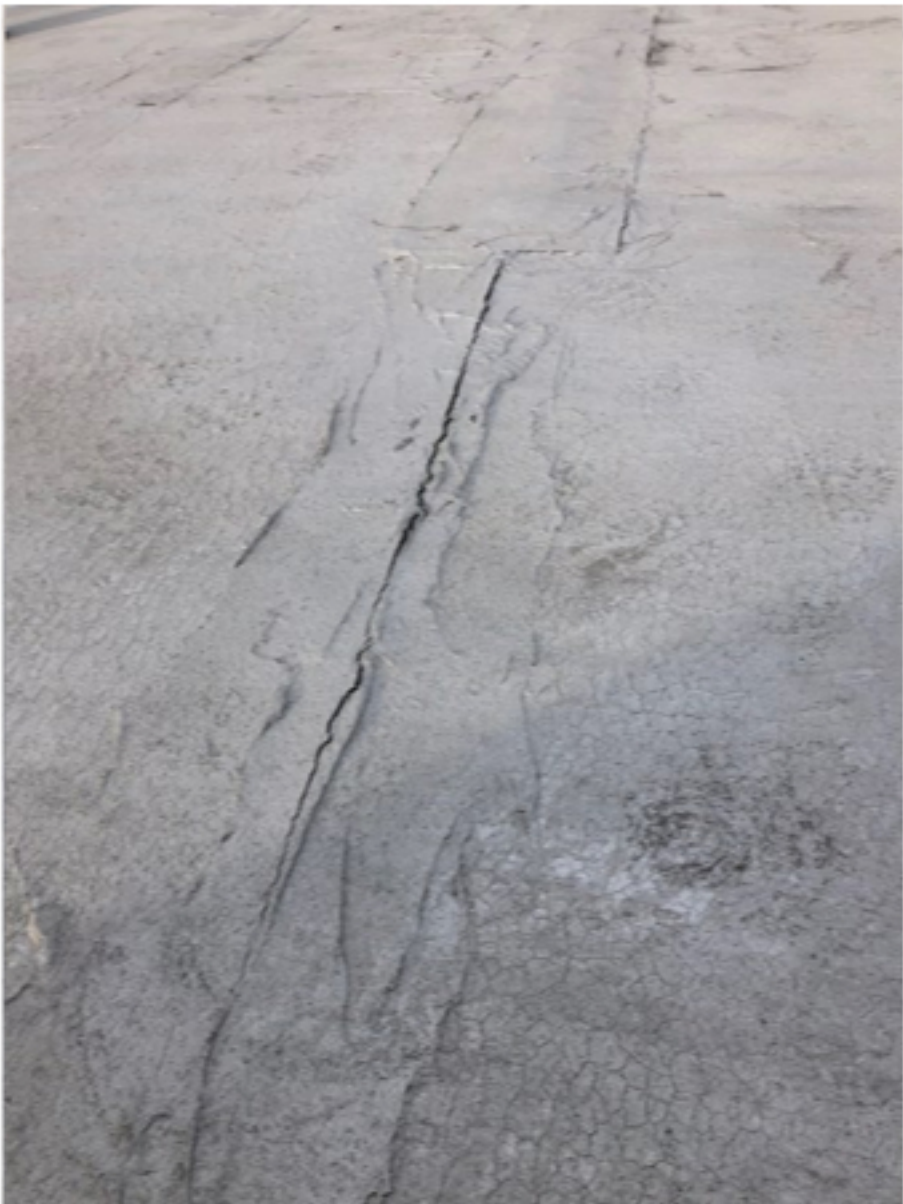
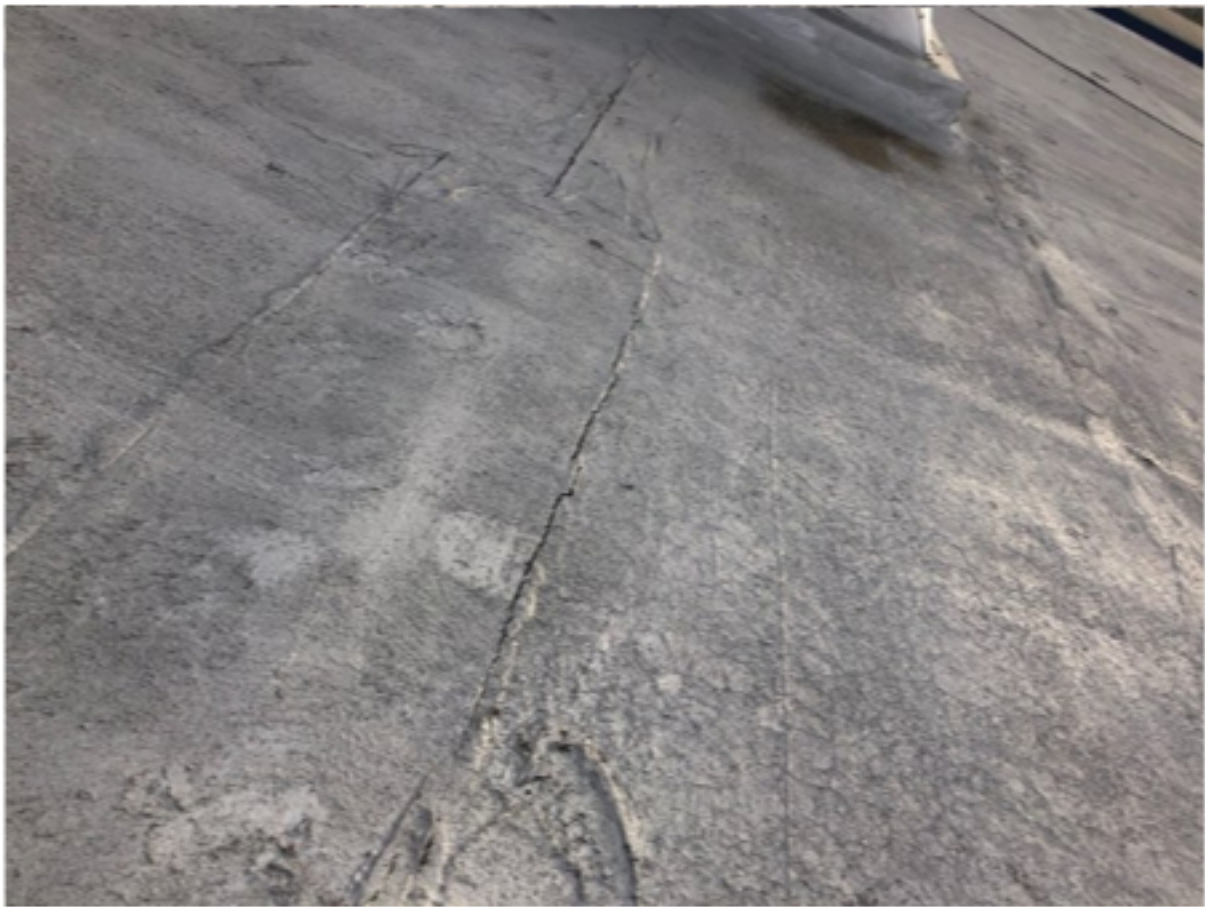
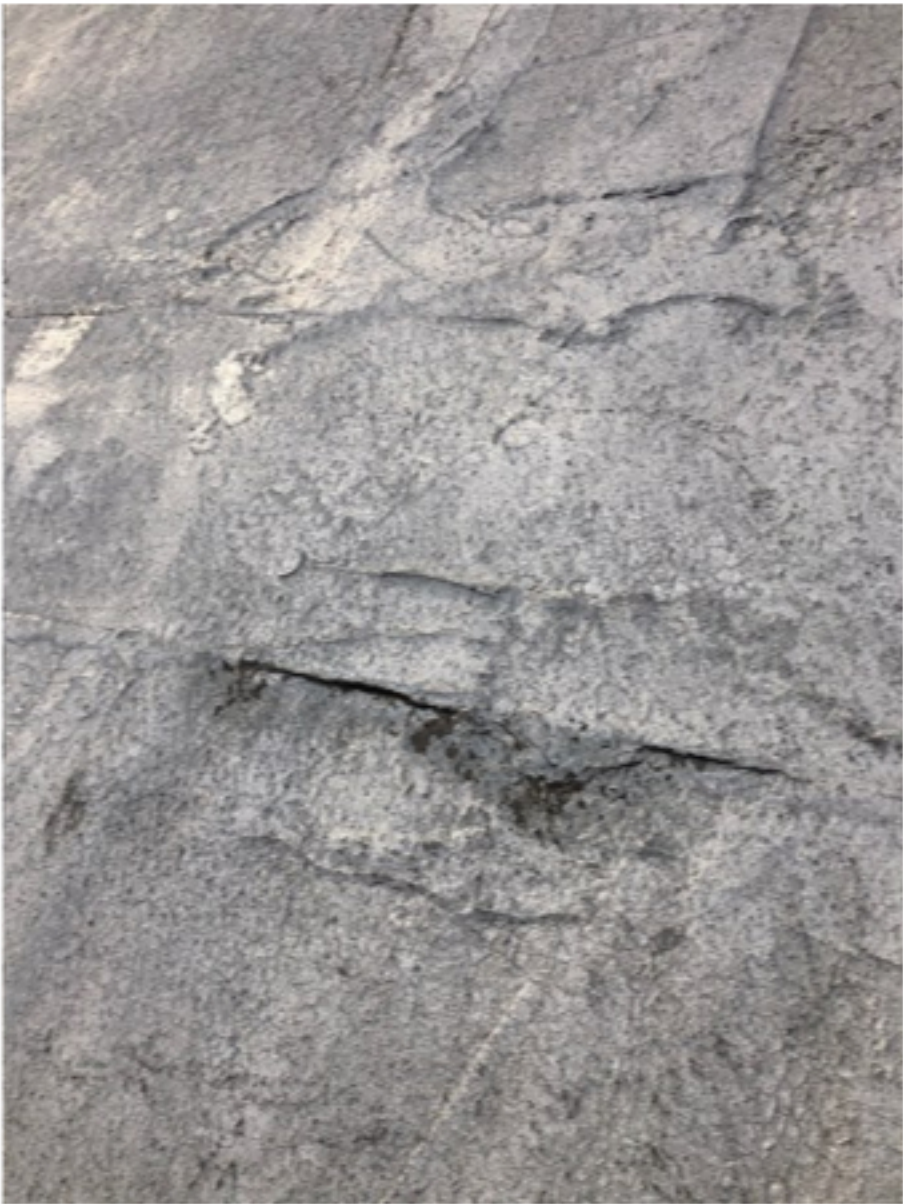
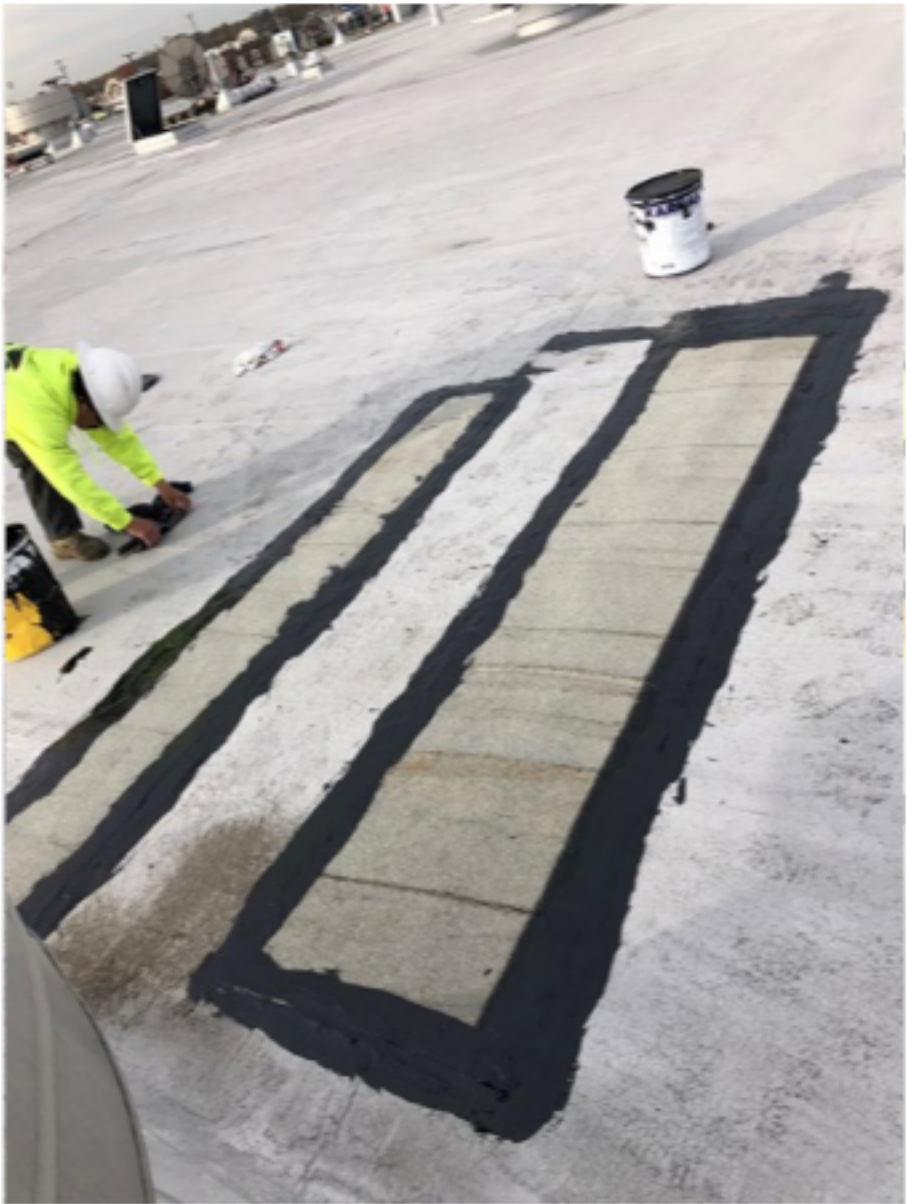
Section 2 Issue #1 Deficiency #1

Deficiency	Description	Deficiency Effect	Severity	Action
Splitting	The formation of long cracks, usually completely through a membrane representing a tension failure of the membrane caused by a loss of it's tensile strength or by movement of the substrate.	Splitting can result in water penetration into the roof system and the building's interior. Once a roof starts to split, this is often a reoccurring phenomenon.	Major	Repaired
