Roof Condition Report

Inspection Date: 7/20/1969

Inspection Type: Thermal Image Report

Gross Roofing & Sheet Metal LLC 101 N. Barron St., Ste 203 Eaton, OH 45250 937-456-3024

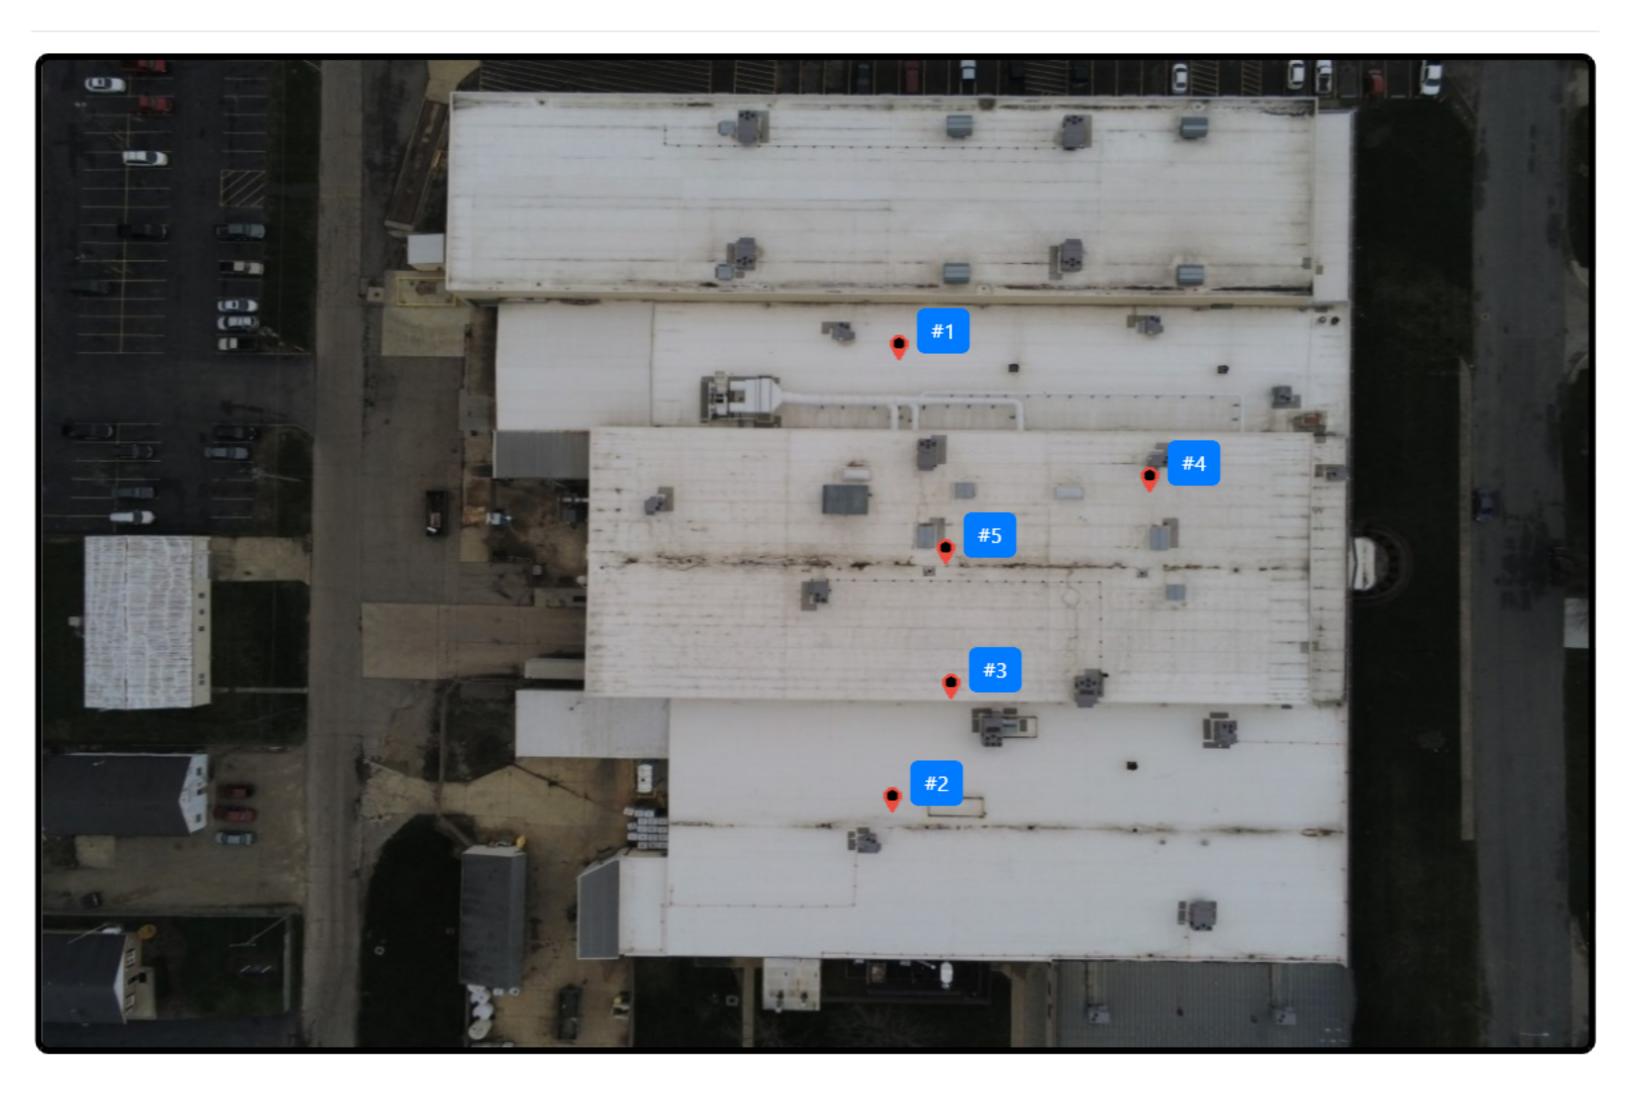
The areas that are bright red are active units. The areas with lighter red are where moisture is present under the membrane.

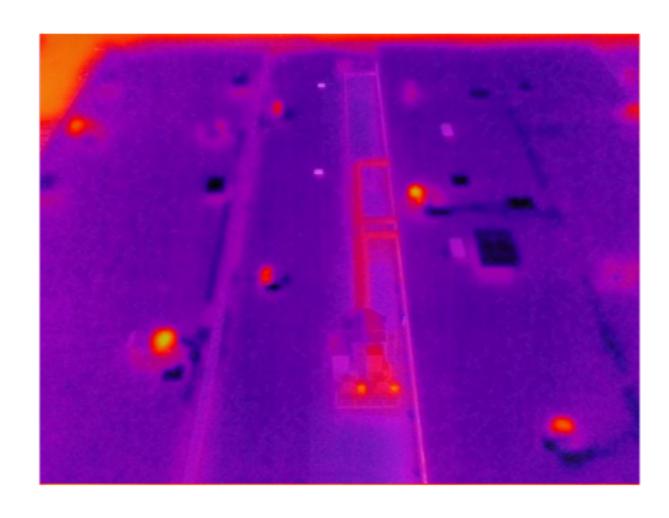
Section Issue #1 Deficiency #1

Deficiency	Description	Deficiency Effect	Severity	Action
Insulation saturation	Saturation of insulation products can be caused when water infiltrates the system at splits or holes in the roof surface.	Saturation of the insulation products is an indication of a deficiency in the roof membrane that has permitted leakage. R-value and insulation integrity are degraded by the exposure and saturation of the product with moisture.	Moderate	Monitor

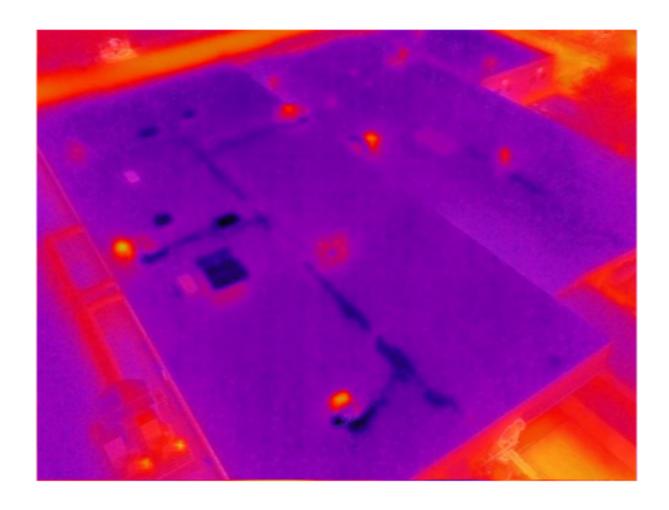
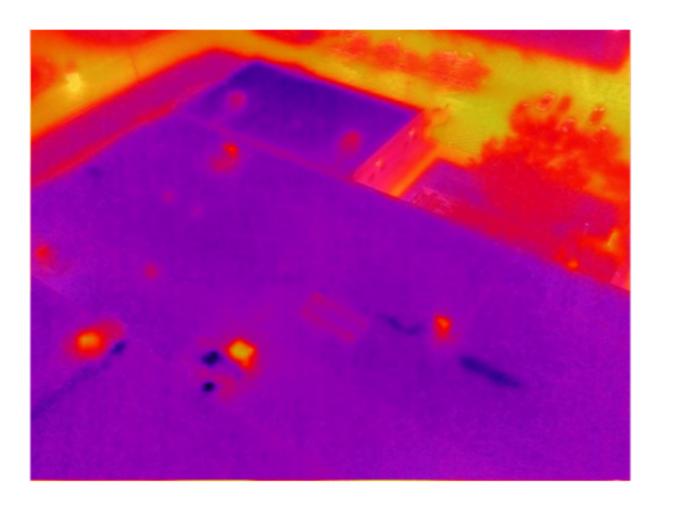
Section Issue #2 Deficiency #1

Deficiency	Description	Deficiency Effect	Severity	Action
Insulation saturation	Saturation of insulation products can be caused when water infiltrates the system at splits or holes in the roof surface.	Saturation of the insulation products is an indication of a deficiency in the roof membrane that has permitted leakage. R-value and insulation integrity are degraded by the exposure and saturation of the product with moisture.	Moderate	Monitor

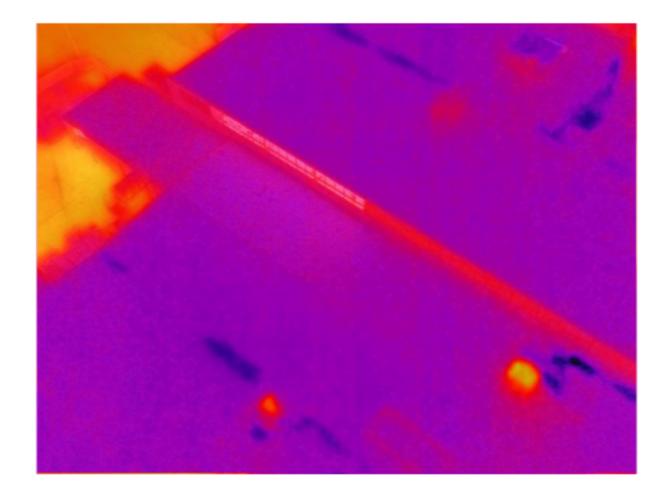
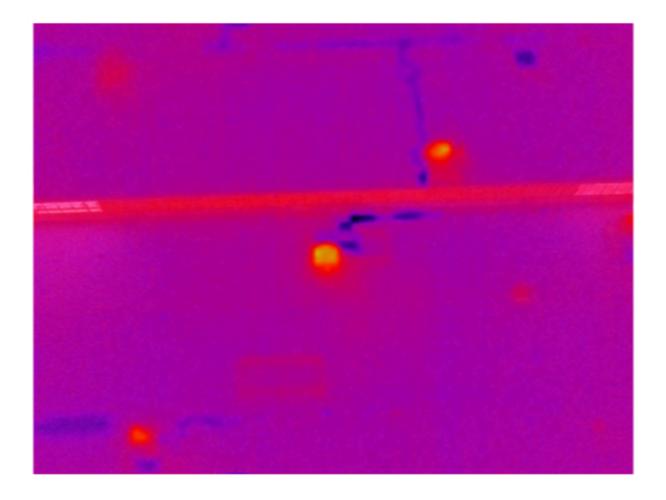
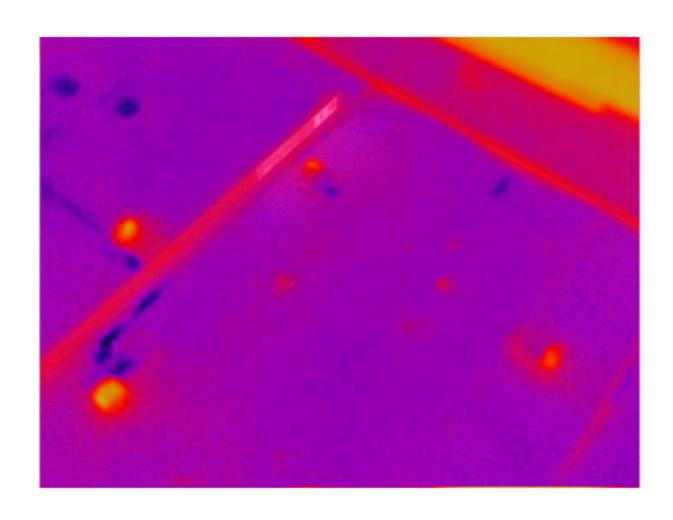
Section Issue #3 Deficiency #1

Deficiency	Description	Deficiency Effect	Severity	Action
Uninsulated Wall	The wall isn't insulated from the interior or exterior.	This will cause you to lose a significant amount of heat/air.	Moderate	Monitor

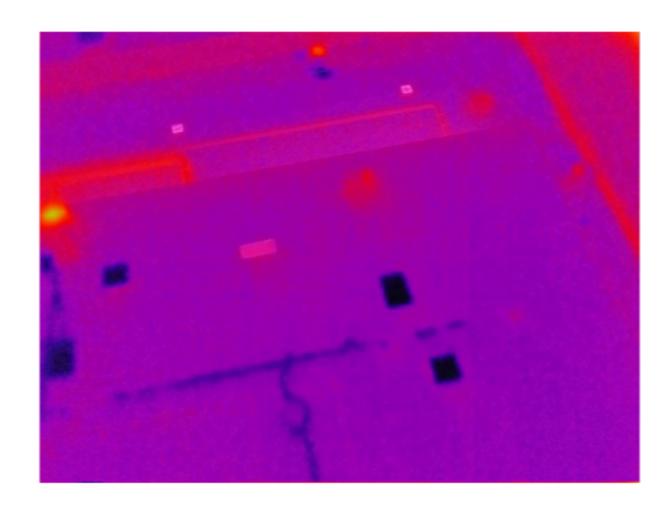
Section Issue #4 Deficiency #1

Deficiency	Description	Deficiency Effect	Severity	Action
Insulation saturation	Saturation of insulation products can be caused when water infiltrates the system at splits or holes in the roof surface.	Saturation of the insulation products is an indication of a deficiency in the roof membrane that has permitted leakage. R-value and insulation integrity are degraded by the exposure and saturation of the product with moisture.	Moderate	Monitor

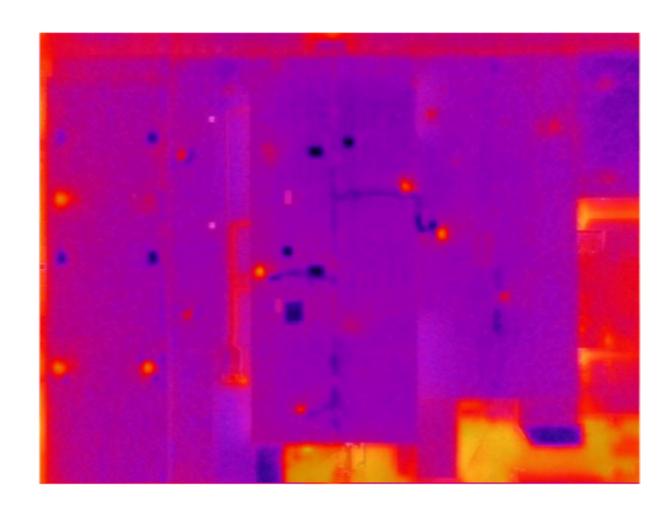
Section Issue #5 Deficiency #1

Deficiency	Description	Deficiency Effect	Severity	Action
Insulation saturation	Saturation of insulation products can be caused when water infiltrates the system at splits or holes in the roof surface.	Saturation of the insulation products is an indication of a deficiency in the roof membrane that has permitted leakage. R-value and insulation integrity are degraded by the exposure and saturation of the product with moisture.	Moderate	Monitor
