Roof Condition Report

Inspection Date: 7/4/1776
Inspection Type: Roof Condition Report

Facility Name
Address
City, State
Building Type: Building Type
Neighborhood: Neighborhood

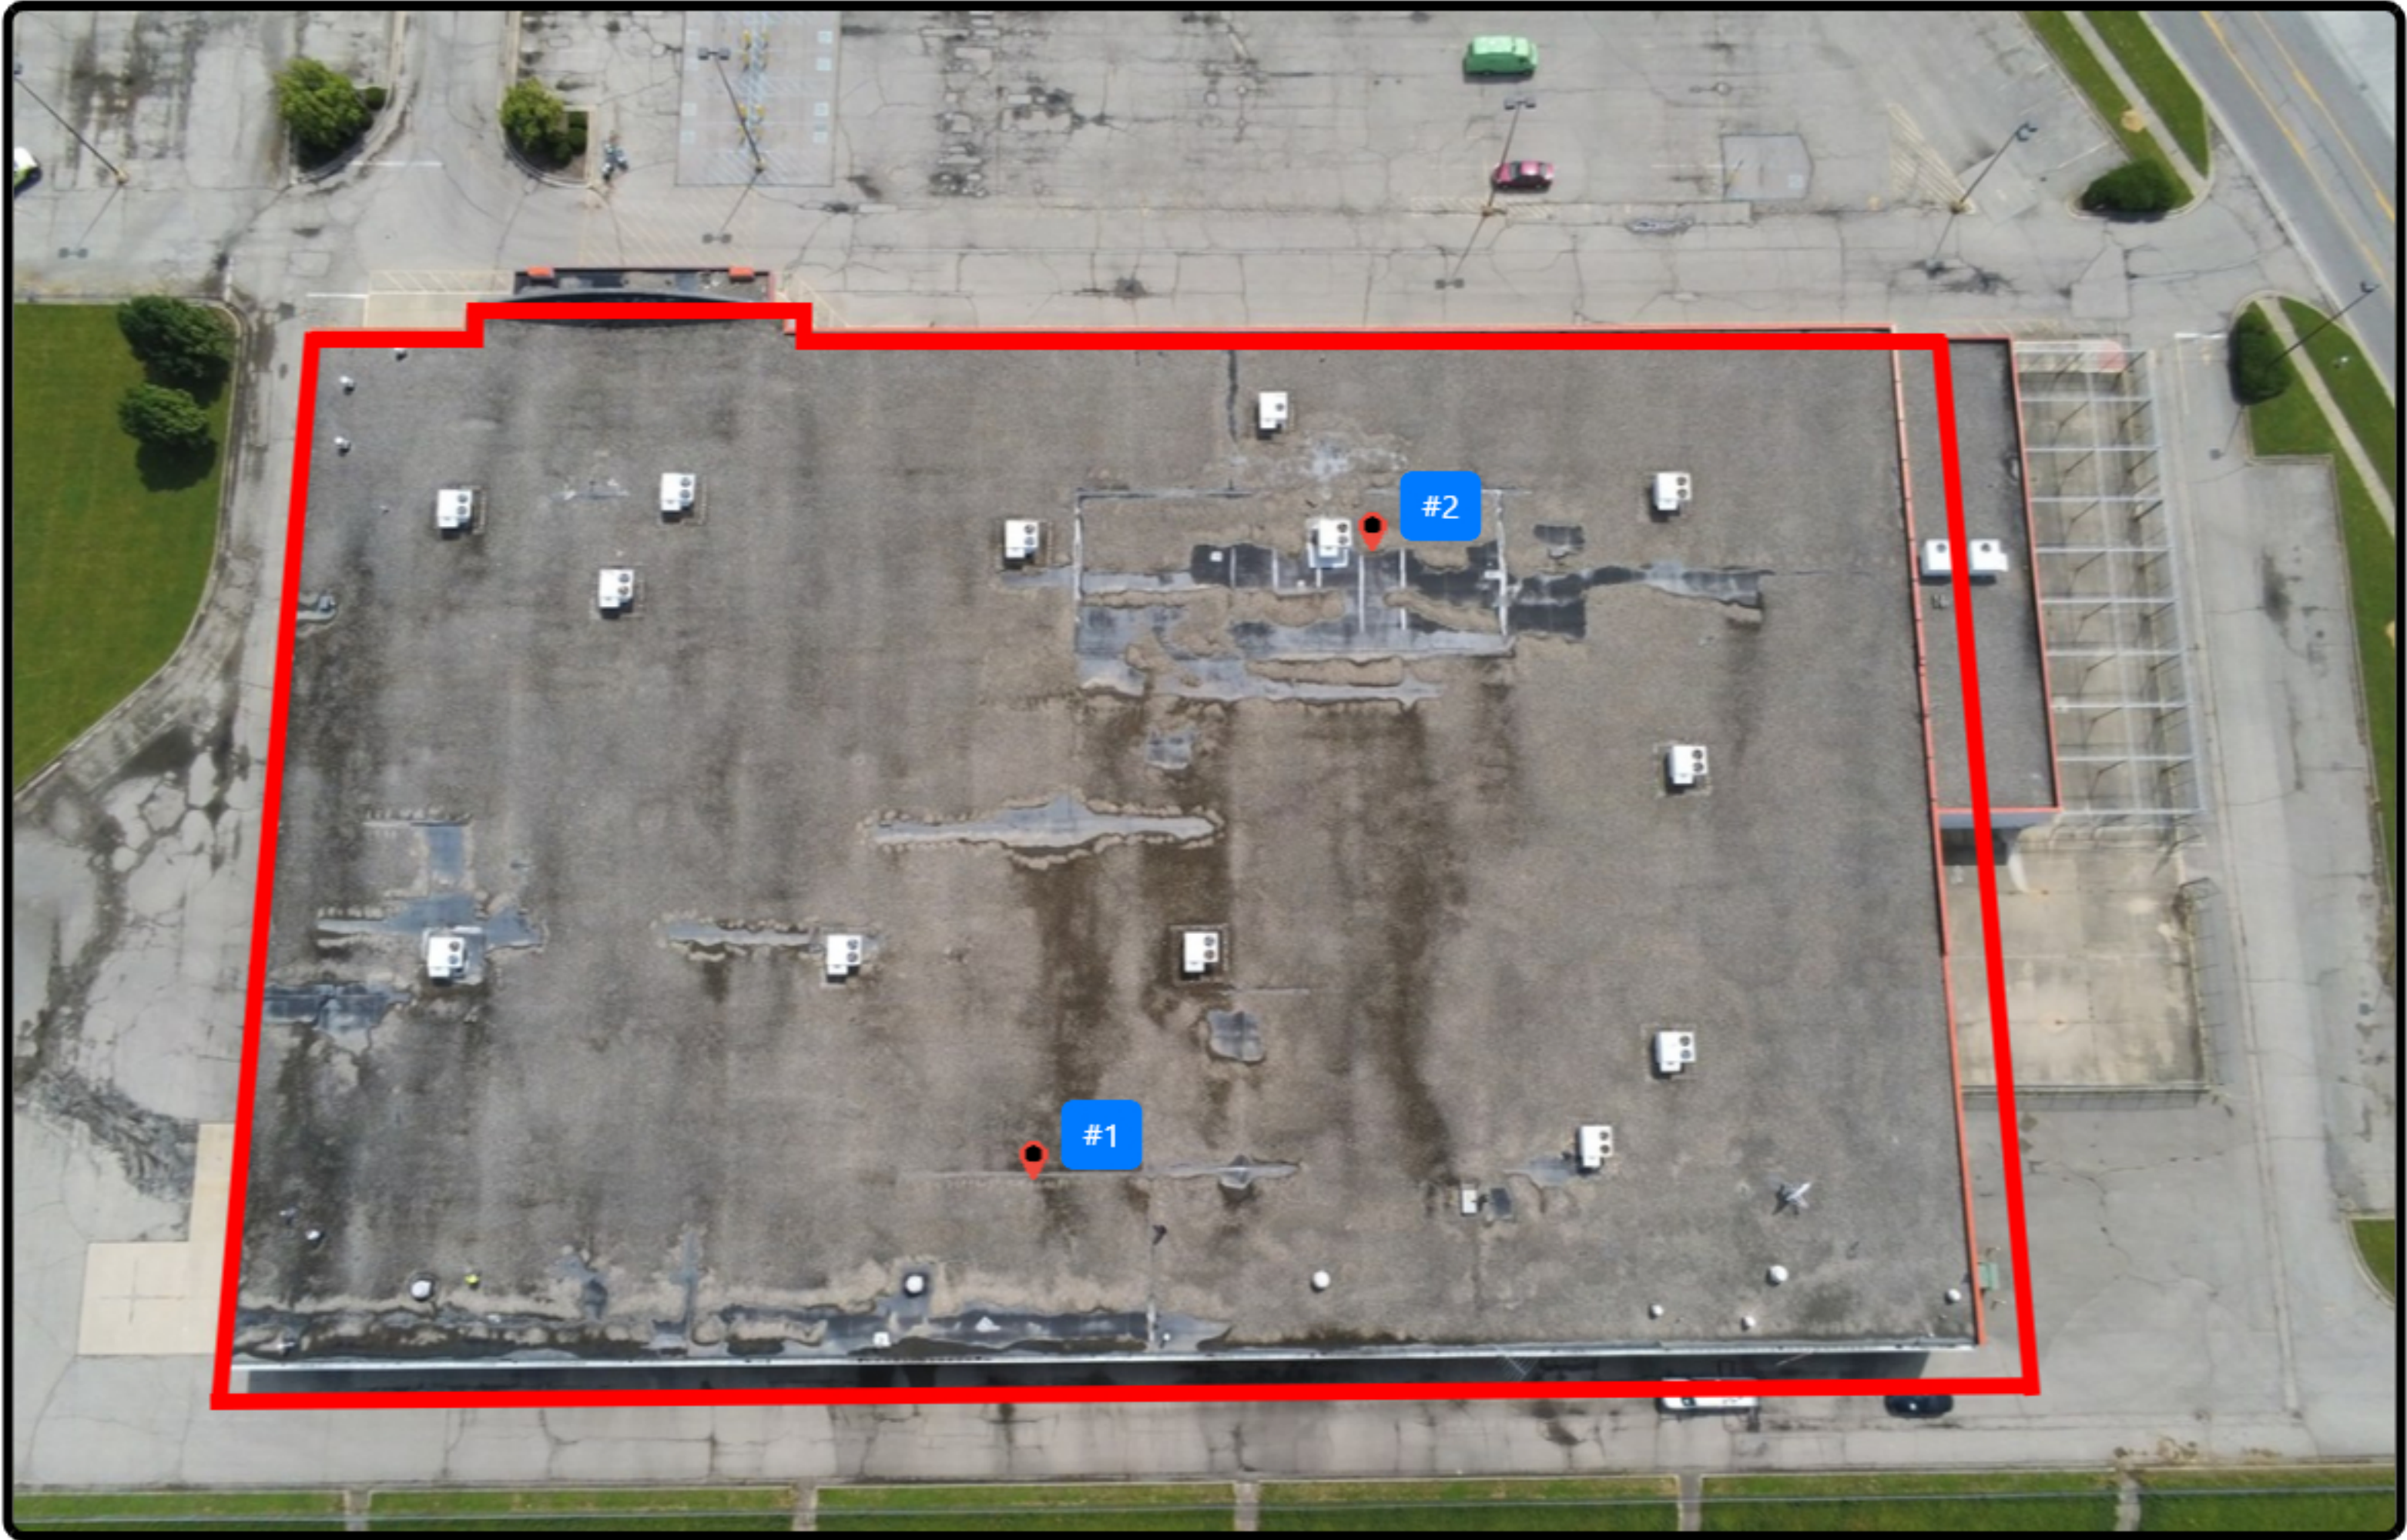
Section 1 Issue #1 Deficiency #1

Deficiency	Description	Deficiency Effect	Severity	Action
Tear or cut	Tear, Cut, or Abrasion of the EPDM membrane could permit water to enter the roofing system.	Lack of action to correct a tear or cut in the membrane will promote saturation of the roofing system. Long term neglect of this condition could contribute to premature failure of the roof area.	Major	Repaired

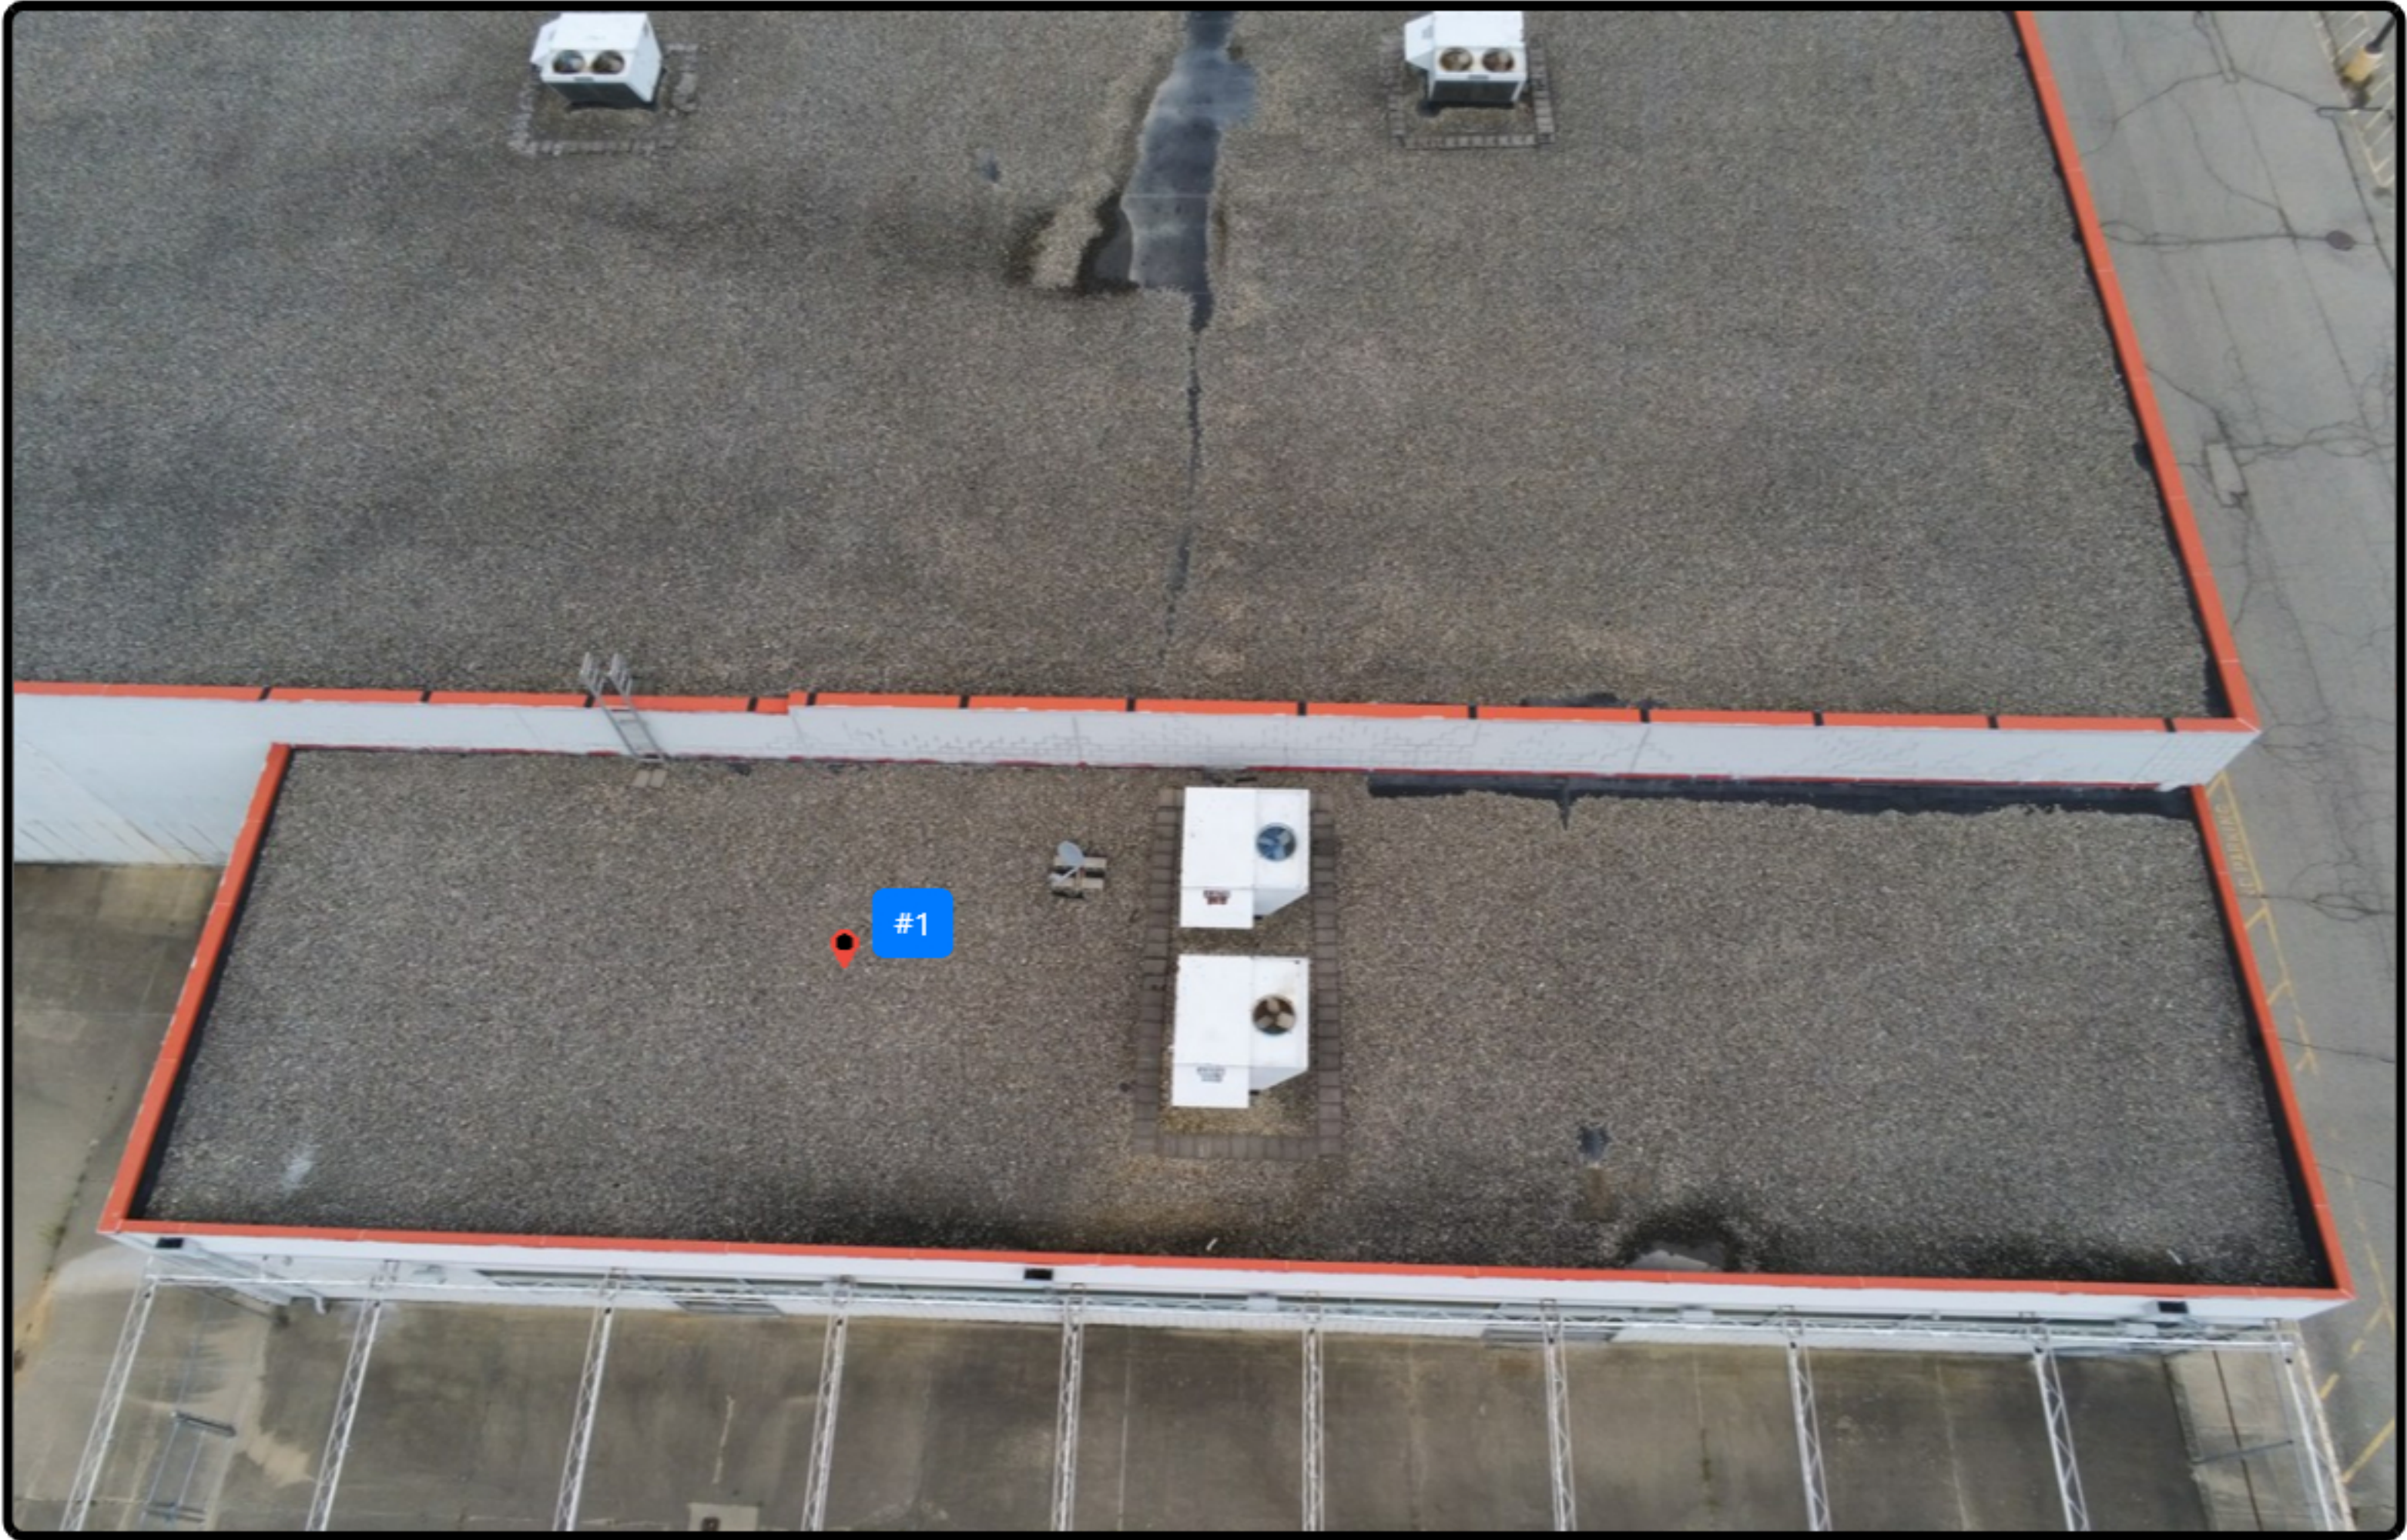
Section 2 Issue #1 Deficiency #1

Deficiency	Description	Deficiency Effect	Severity	Action
Splitting	The formation of long cracks, usually completely through a membrane representing a tension failure of the membrane caused by a loss of it's tensile strength or by movement of the substrate.	Splitting can result in water penetration into the roof system and the building's interior. Once a roof starts to split, this is often a reoccurring phenomenon.	Major	Repaired
