Roof Condition Report

Inspection Date: 7/20/1969

Inspection Type: Thermal Image Report

Gross Roofing & Sheet Metal LLC 101 N. Barron St., Ste 203 Eaton, OH 45250 937-456-3024

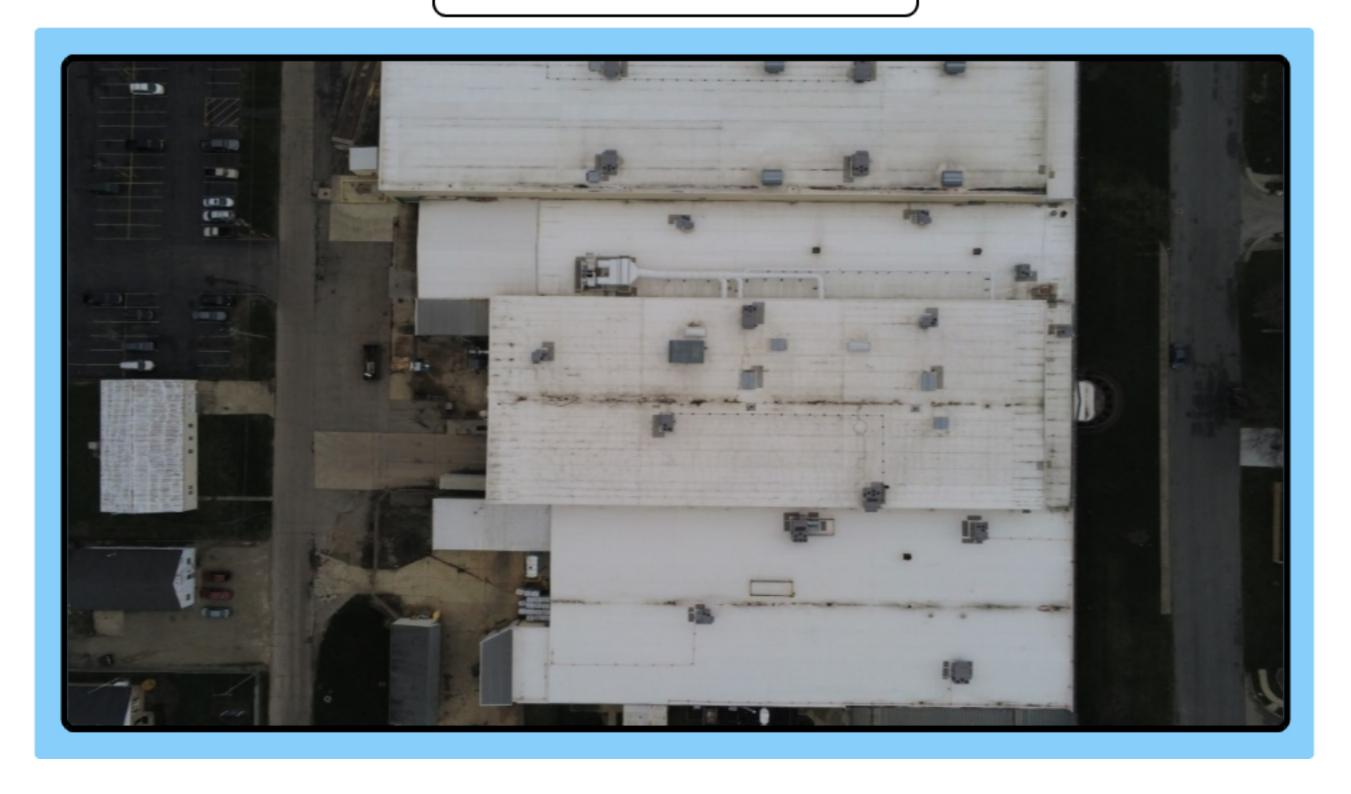
The areas that are bright red are active units. The areas with lighter red are where moisture is present under the membrane.
